REPORT OF SAMPLING ACTIVITIES
RICHARDSON FLAT TAILINGS
SUMMIT COUNTY, UTAH
TDD R8-8505-27

EPA REGIONAL SITE PROJECT OFFICER: ERIC JOHNSON
E&E PROJECT OFFICER: SUSAN KENNEDY

DATE SUBMITTED: SEPTEMBER 30, 1985

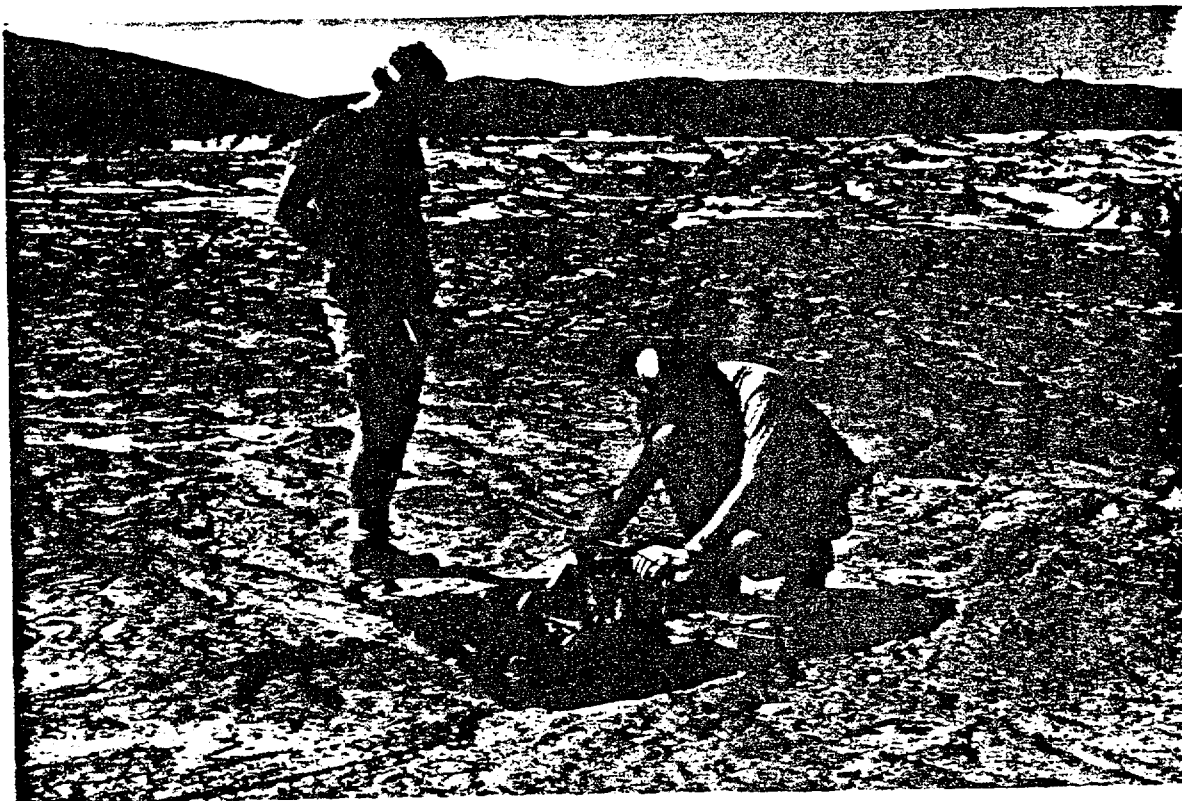
Four surface tailings samples were collected from dispersed locations on the tailings. Photo 5 shows FIT members collecting a composite surface tailings sample (RT-SO-6), where a surficial salt crust is evident. The fourth tailings sample location was added to photo document air-borne tailings material while simultaneously sampling from the source (Photo 6). Surface soil and tailings samples were composited from a triangular grid, and collected with a stainless steel spoon from the top zero to six inches. Surface soil and tailings samples were analyzed for total metals and cyanide.

PHOTO 5: FIT MEMBERS COLLECTING COMPOSITE SURFACE TAILINGS
SAMPLE, RT-SO-6.

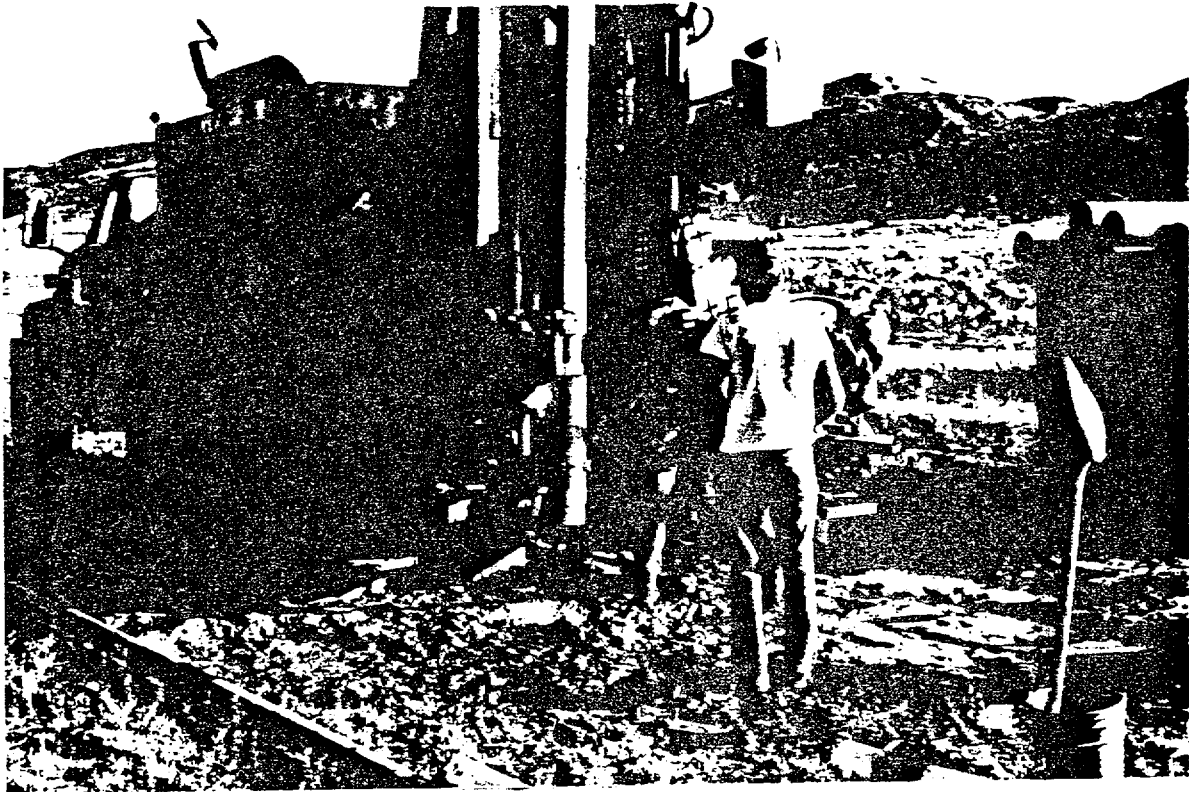
Drilling commenced on Thursday, August 1, 1985 with the upgradient well, RT-1 (Photo 3). The drill site was chosen primarily because of good access and the upgradient location. The drilling was easy and a highly productive gravel zone was found at 34 to 36 feet. Split spoon samples were collected from five to seven feet deep. The same day, a monitoring well was installed and completed at a depth of 38 feet in accordance with Region VIII FIT Standard Operating Procedures for well installation. Detailed drilling and well completion information is provided in Appendix B. The next day, August 2, 1985, the

PHOTO 3: DRILLING HOLE RT-1; SAMPLE STATION FOR RF-GW-1, RF-SS-1 AND RF-SS-2.

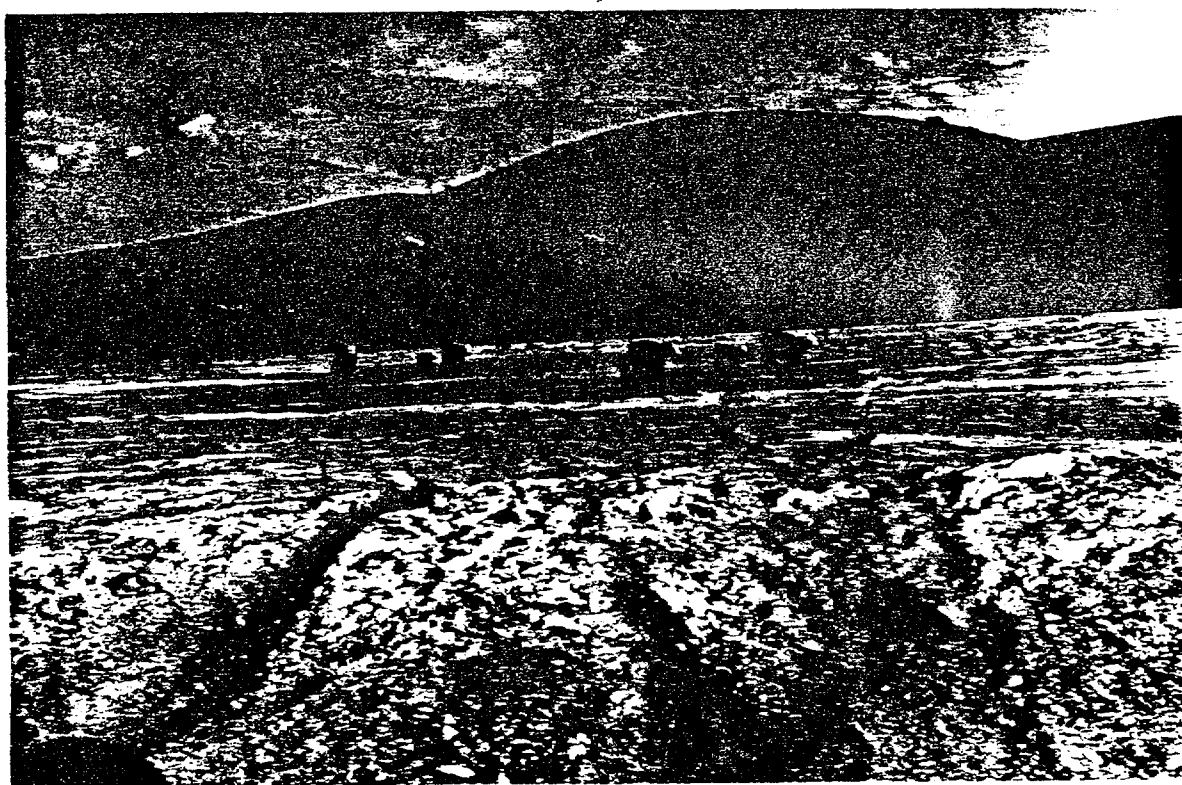
The site is not secured in any way from public access. An unpaved road along the southern boundary of the tailings is unrestricted. Several vehicles were observed using the road on June 19 and 20, however, no on-site activity was noted. Cattle and sheep are grazed in the area, and cattle were observed walking across the tailings on June 20 (Photo 2).

PHOTO 2: CATTLE WALKING ACROSS TAILINGS ON JUNE 20, 1985.

3. Because the tailings contain high levels of metals and arsenic, the area should be fenced to prevent on-site grazing by domestic sheep and cattle, and to keep people off the site.

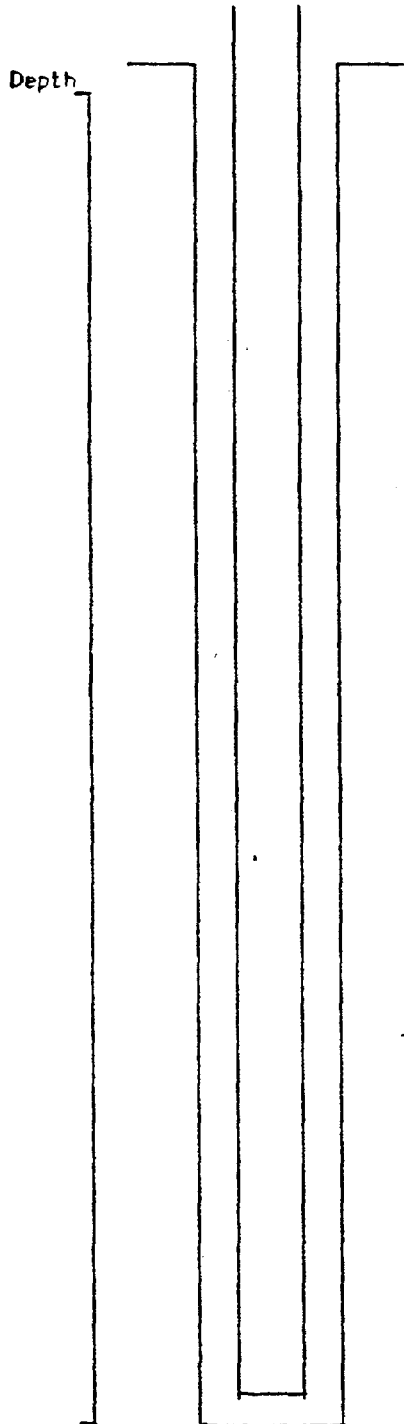
WELL/PIEZOMETER COMPLETION DIAGRAM

Piezometer Number KF-GW-2 ^{MW} Park City Mines ~~LE~~ #2
 Project Rickerson Flats/R8-8505-27
 Aquifer Shallow Alluvial
 Static Water Level 15'

Geologist _____
 Driller _____
 Date of Installation _____
 Hole Depth 42'
 Stickup 8" - broken off
 Protective Casing None to No Cap Total _____
 Well Casing _____ to _____ Total 42'
 Top Seal
 ? from _____ to _____
 ? from _____ to _____
 Hole Diameter ?
 Casing Diameter 3" i.d.
 Well Casing Depth 42'
 Screen Diameter ?
 Centralizers ?
 Pump Type _____
 Pump Capacity _____
 Pump Setting _____
 Average Pumping _____
 Remarks Slow Recharge
Cloudy Water
A+ Base of Tailings Dam
Central Well

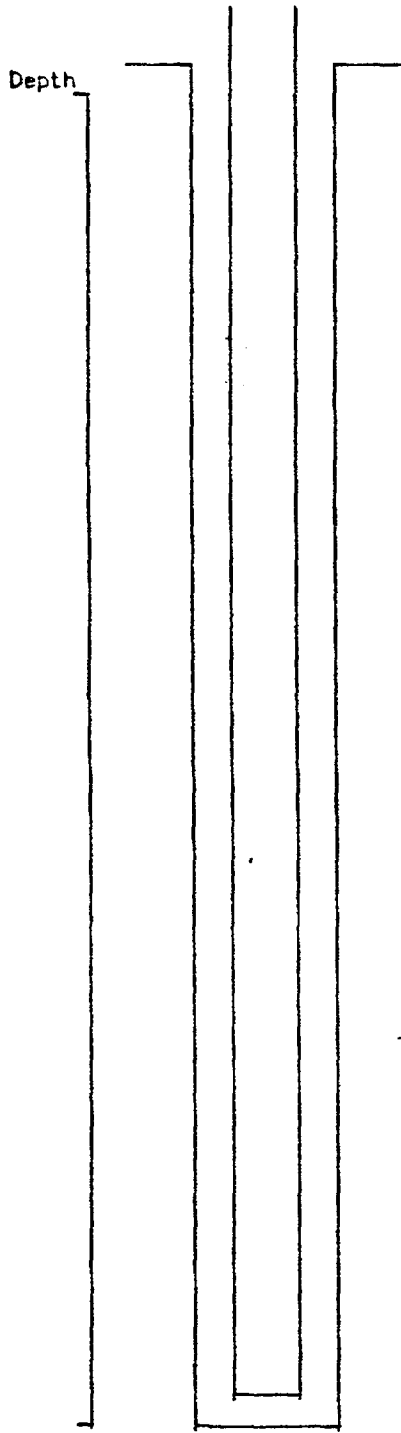
WELL/PIEZOMETER COMPLETION DIAGRAM

Piezometer Number Park City Mines MW #1

Static Water Level 5'

Hole Depth 25'

Remarks Fast Recharge

Cloudy Water

At Base of Tailings Dam
